Manhole Inspection Summary

Manhole # S45G2_024MH

Location Address: **4240 Prudence St**

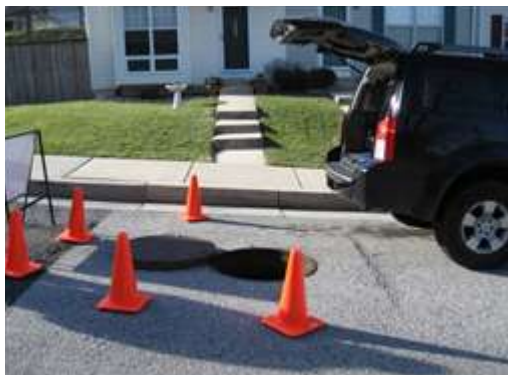
Location View

Prudence St.

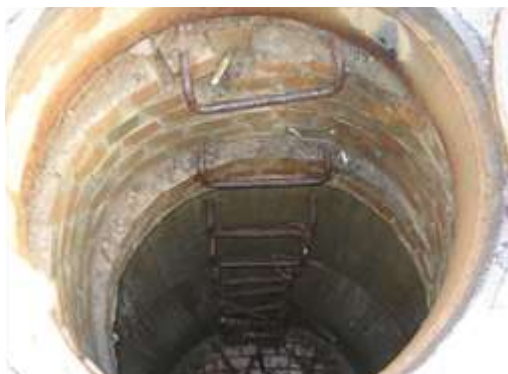
Steps

Count: **9** Missing: **0** ☐ Corroded

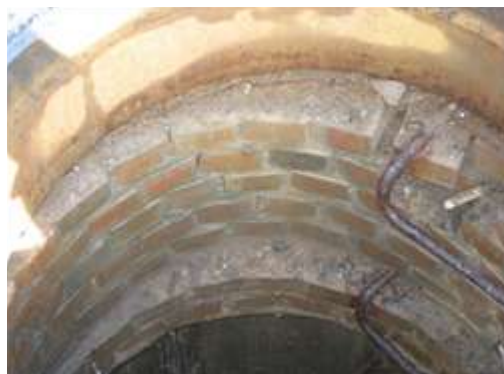
Defect 1

Offset: **2.5** (in.)

Frame offset

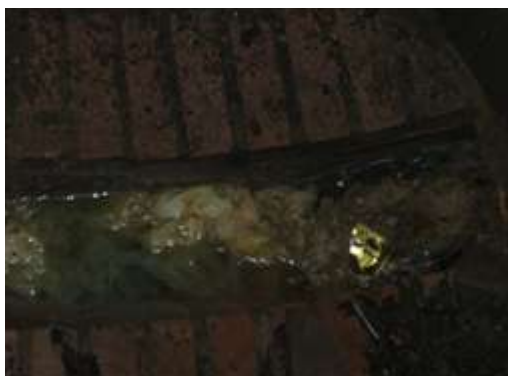
Defect 2

Channel

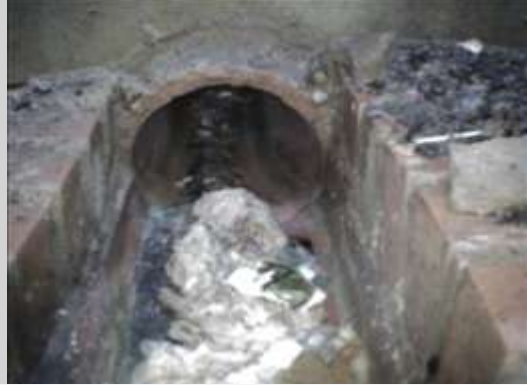
12 O'Clock Outflow

8 in. Circular Gravity Sewer
Pipe Out @ 12 O'Clock

Pipe Height: **10.8** (in.) Rod and Bar (Angled)
Pipe Material: **Clay** ☐ Pipe Lined
Invert Depth: **11.34** (ft.) Flow Characteristics: **Slow**
Deposits: ☒ None ☐ Mud ☐ Sludge ☐ Debris ☐ Grease
Silt Depth: (in.) Deposits Extent:
Infiltration: **None** Pipe Seal Cond: **Sound**

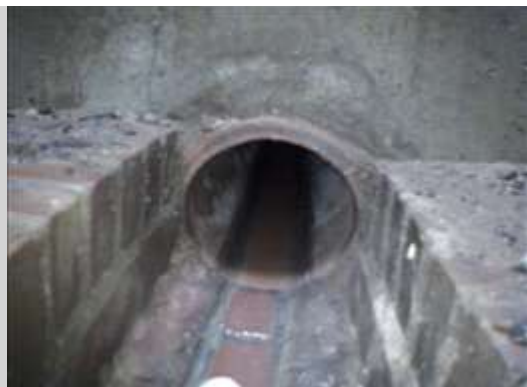
7 O'Clock Inflow

8 in. Circular Gravity Sewer
Pipe In @ 7 O'Clock

Pipe Height: **9.6** (in.) Rod and Bar (Angled)
Pipe Material: **Clay** ☐ Pipe Lined
Invert Depth: **10.89** (ft.) Flow Characteristics: **Slow**
Deposits: ☒ None ☐ Mud ☐ Sludge ☐ Debris ☐ Grease
Silt Depth: (in.) Deposits Extent:
Infiltration: **None** Pipe Seal Cond: **Sound**
